**Property Condition Report
165 Ontario St.
St. Catharines, Ontario**

July 24, 2008
Project: 80-13-089426

**165 ONTARIO STREET
ST. CATHARINES, ONTARIO
2012 EXTERIOR CLADDING REPAIRS**

**GRGAS PROJECT #09039.06
ISSUED: JULY 19, 2012**

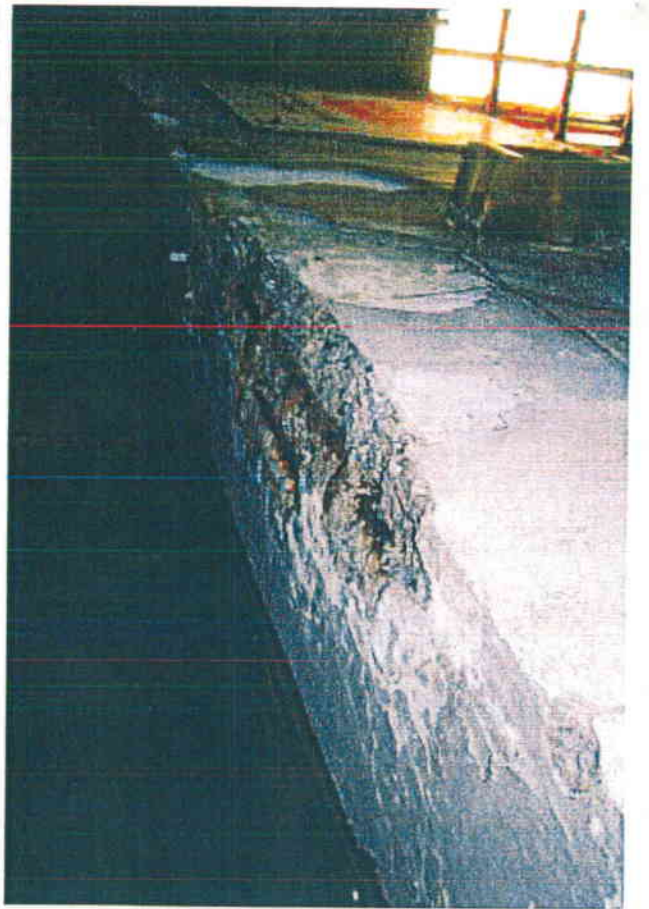
B21. Spalling at garage entrance.

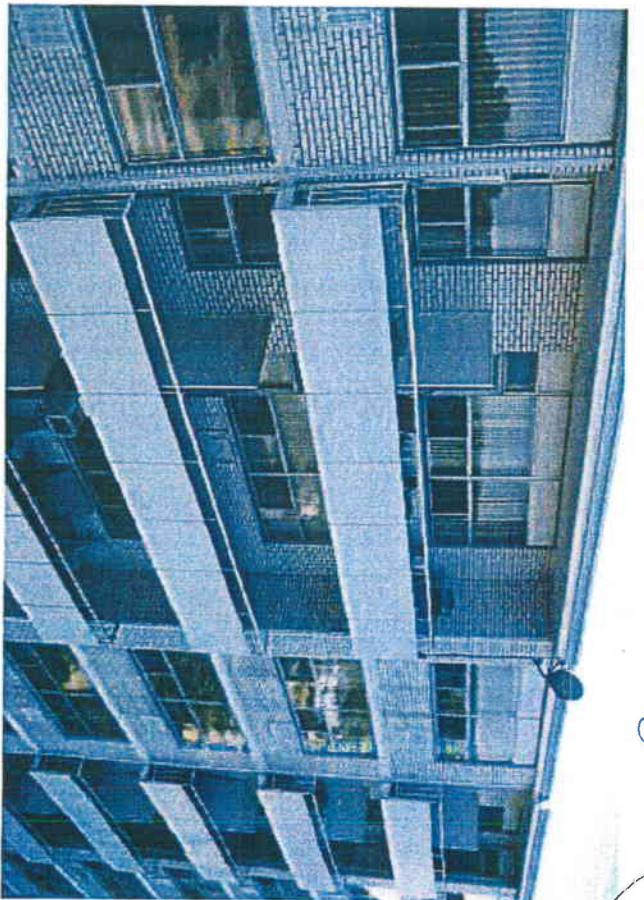
B22. Typical balconies.

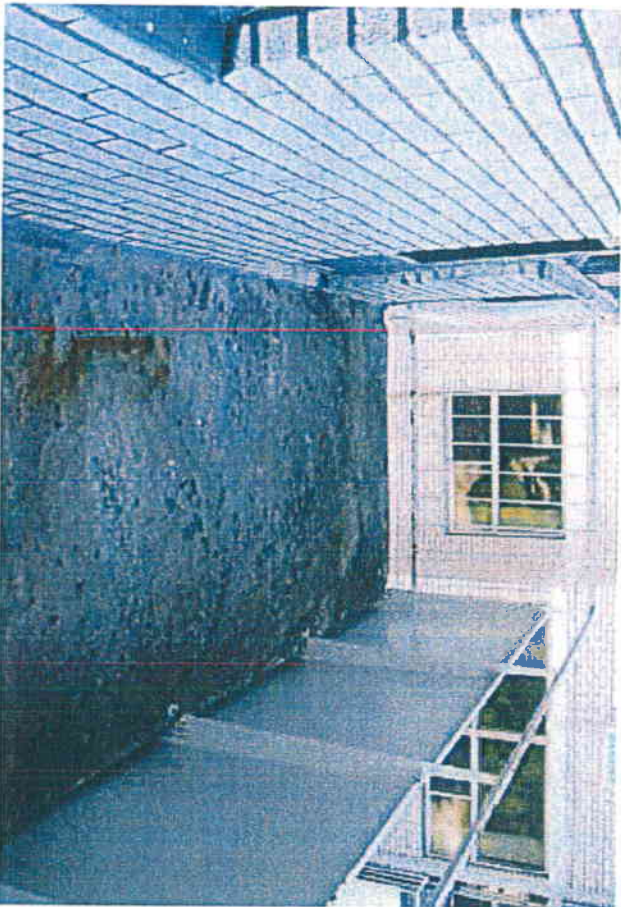
B23. Typical balcony.

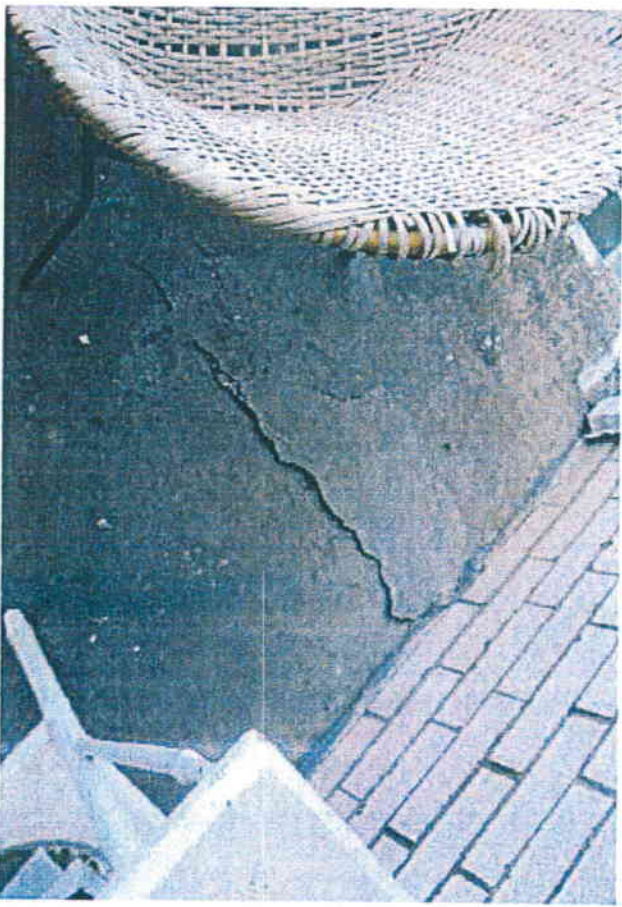
1. Delamination and spalling was observed on the top sides of approximately 10% of the balcony slabs.
2. Narrow cracks on the top of the balcony slabs running perpendicular to the building were typical. There was generally little evidence of water movement through the cracks. The cracking appears to be positioned at the steel reinforcement and is likely thermally induced.

3. Evidence of previous repairs was observed on the balcony slabs. It was reported that the repairs took place in 2000.
4. The slab soffits have cast drip edges. Peeling paint was observed at the edges and on many balconies past the drip edges to approximately 12" from the edge.

B24. Delaminated concrete on balcony slab at previous repair.

The balcony decks were generally in fair to good condition. The cracks appear to be at the reinforcing steel. They appear to be thermally induced. The cracks are not a structural concern at this time. Repairs to the spalled areas should be completed. The cracks should be routed and sealed in the near future. If left as-is, concrete deterioration will continue and extensive repairs will eventually be required. Consideration could be given to waterproofing the balcony slab subsequent to the concrete repairs.

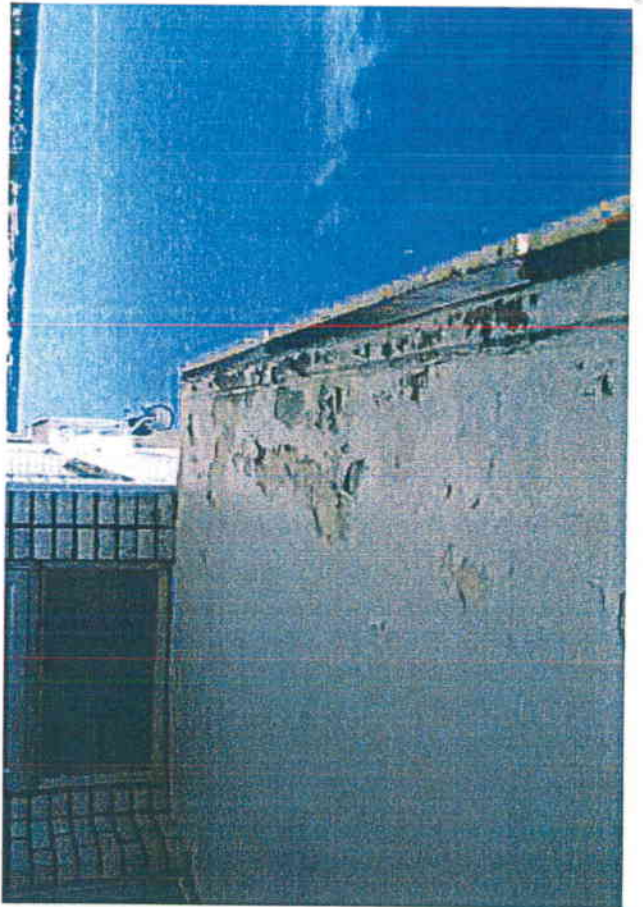
B25. peeling paint on balcony slab soffit.

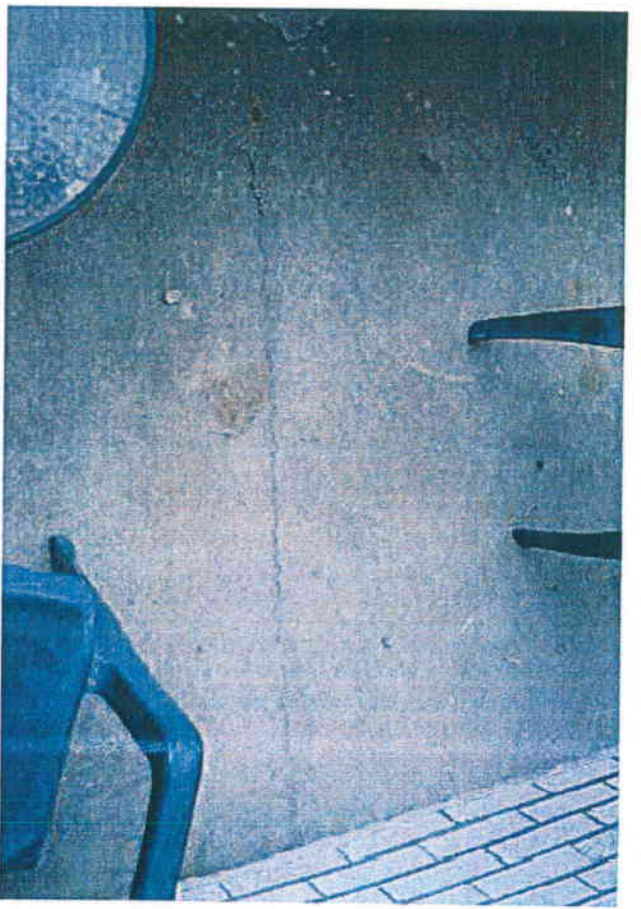
B26. Crack in balcony slab.

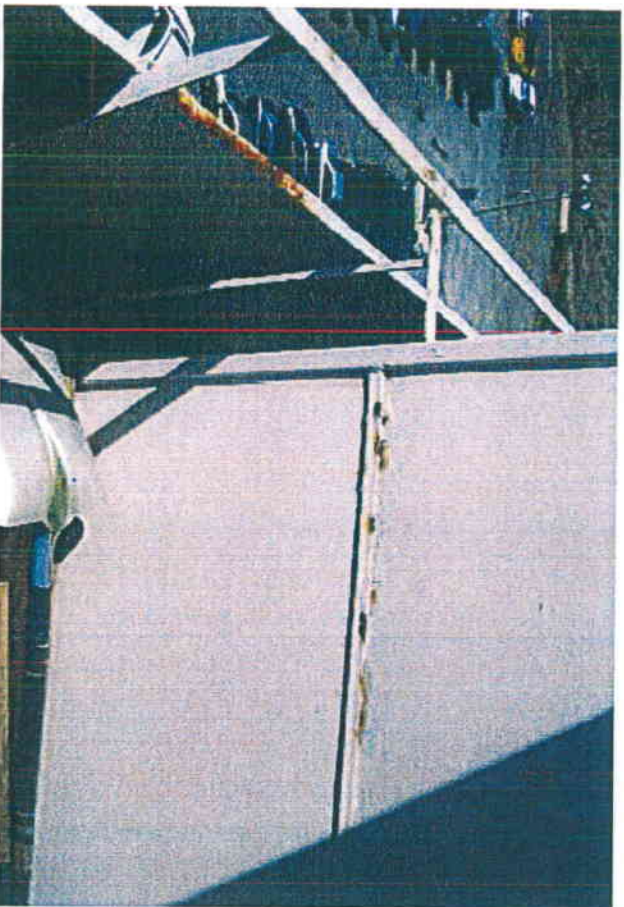
6. The paint finish on the guards and privacy panels is weathered and peeling. Surface corrosion was observed throughout and severe corrosion was noted in a few locations.

B27. Peeling paint and corrosion on balcony guard and privacy panel.

The balcony guards are in fair structural condition. Repairs and refinishing the guards will be required in the near future. The guards do not meet the dimensional requirements of the current Building Code. Complete replacement of the guards is at the discretion of the Owner, but should be considered.

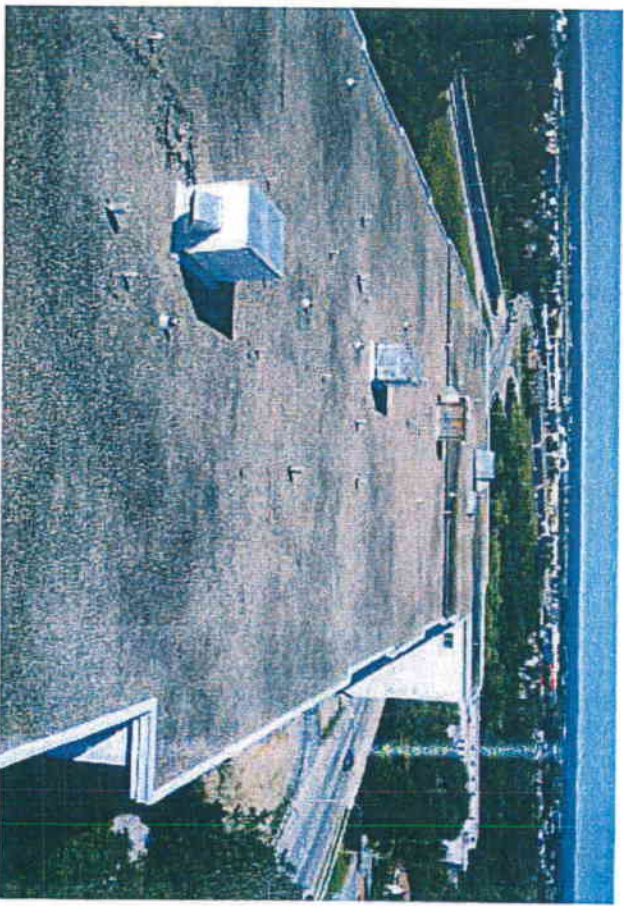
B28. Overview of roof.
