# Tenant Submission

## Above Guideline Increase LTB-L-076488-23

File Number: LTB-L-076488-23

## **Tab 1 – Balcony Restoration**

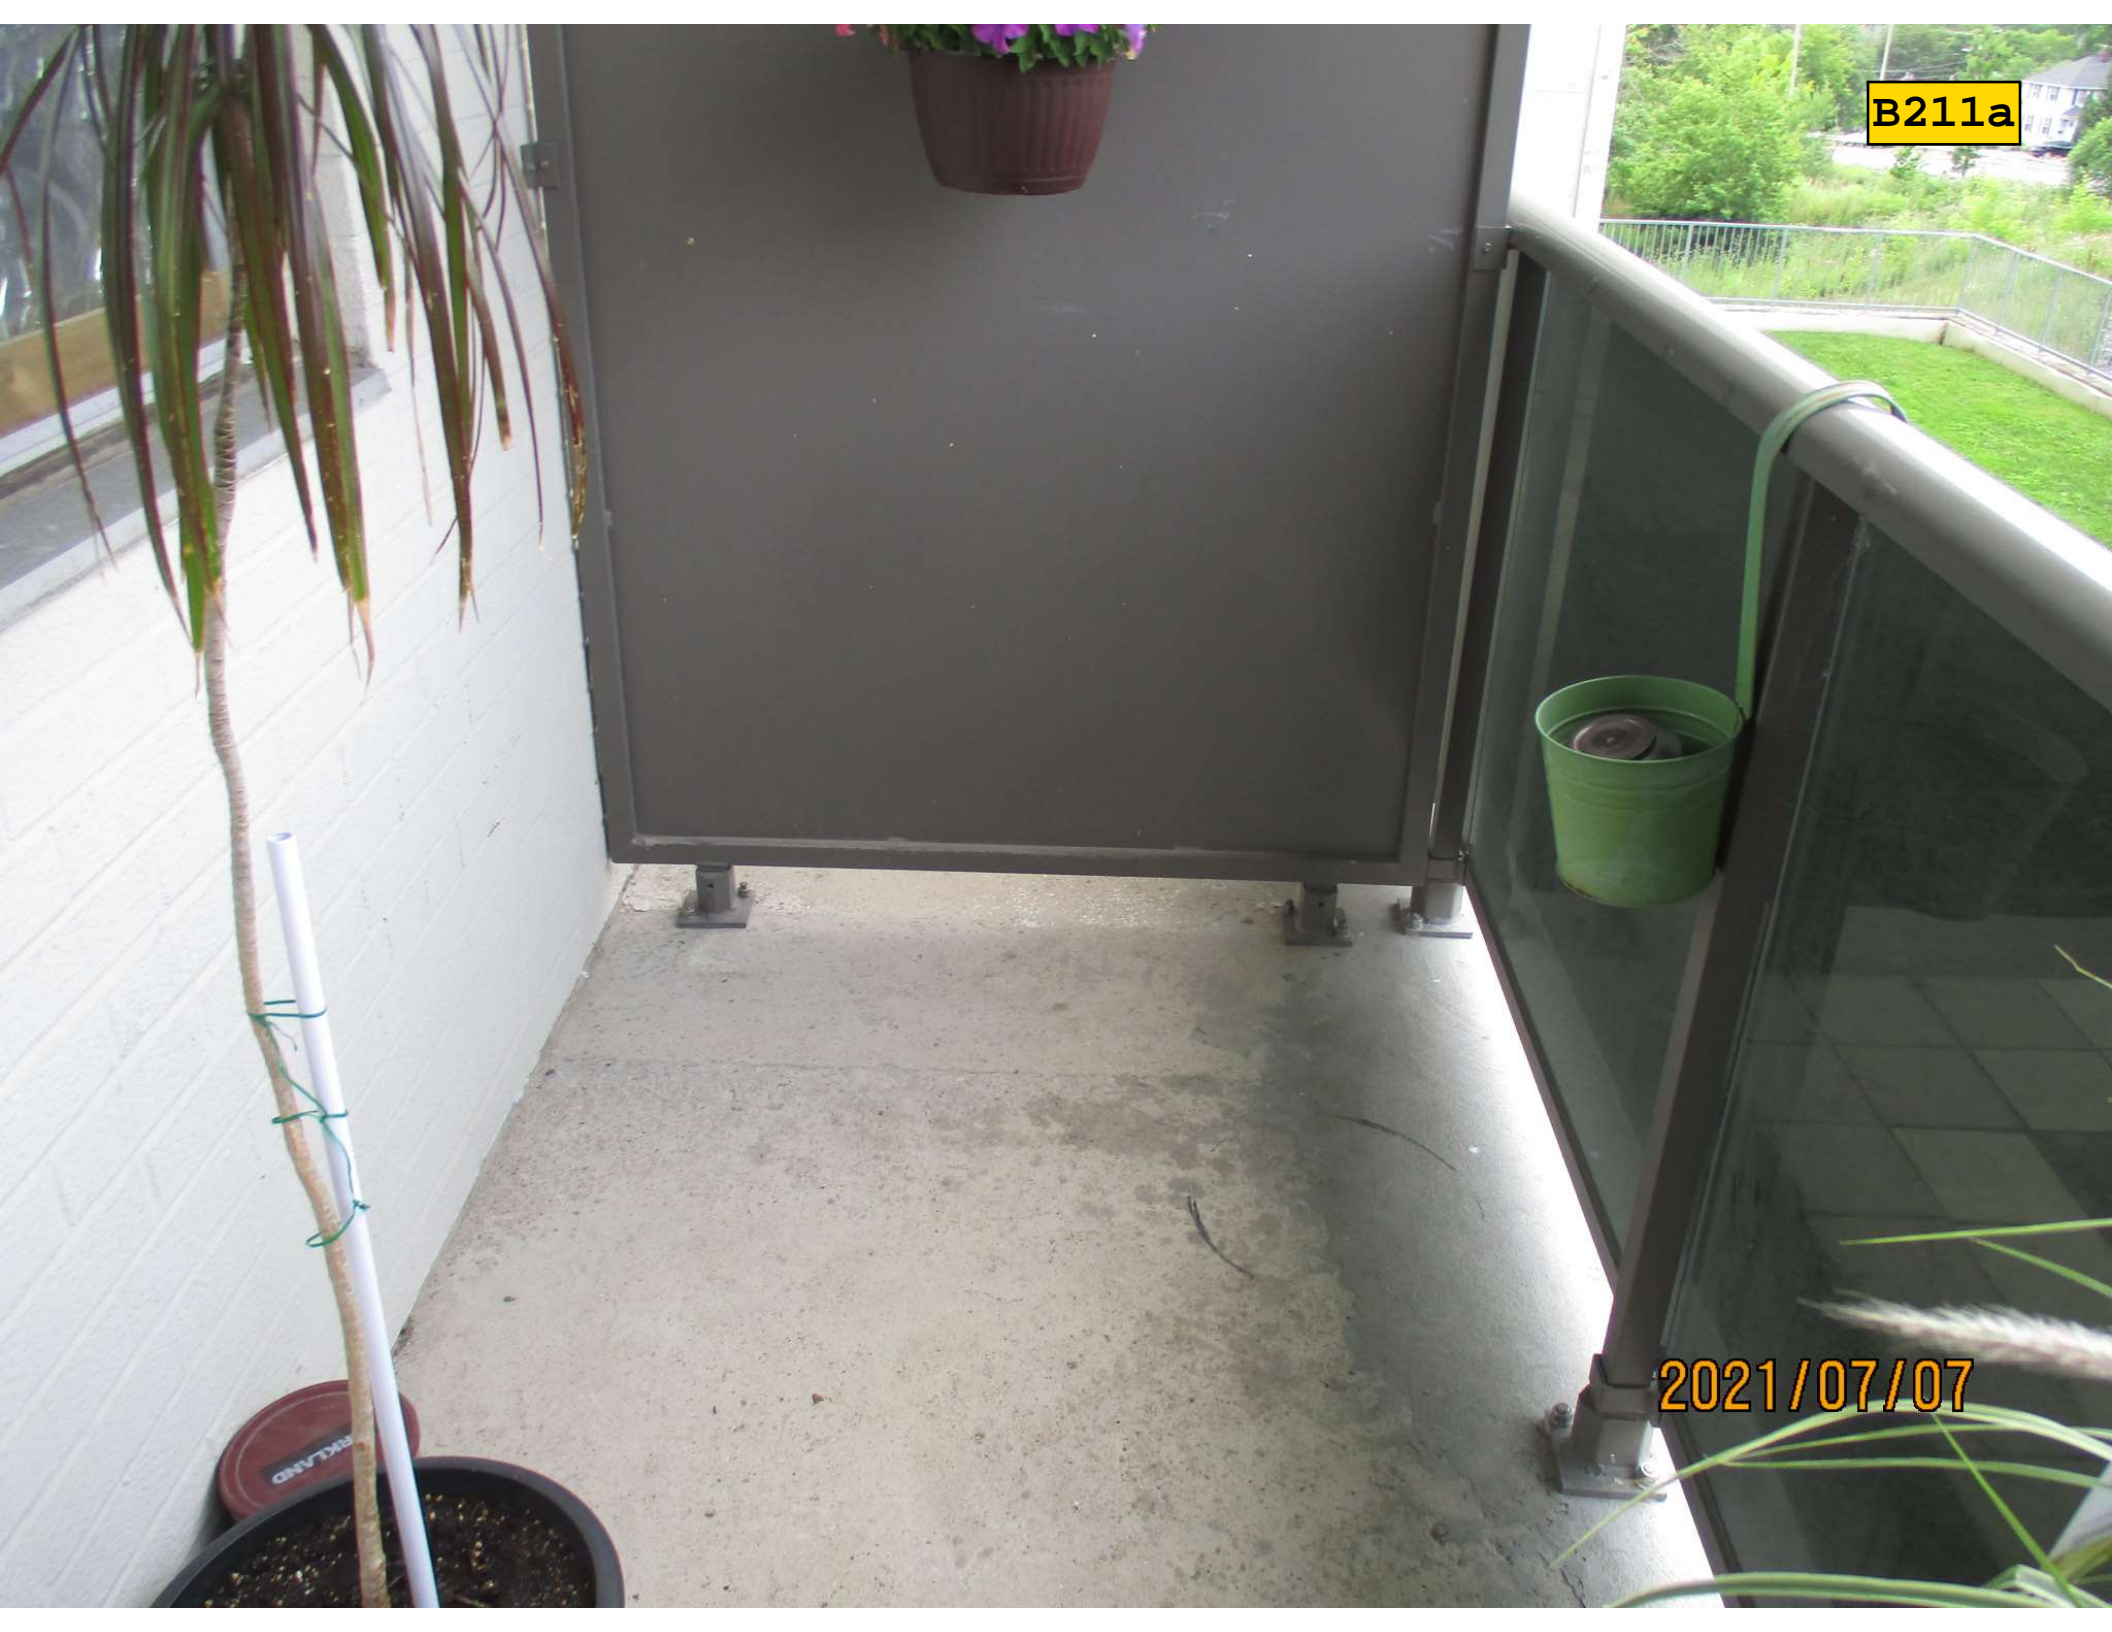
B211a

- A. In the Balconies section there are two images of each balcony, indexed by apartment number. One is taken from left to right and the other from right to left, so the entire balcony is visible.

7. Studying these pictures shows us balconies in good condition, being used and enjoyed by tenants. There is no evidence of deterioration, wear or damage.

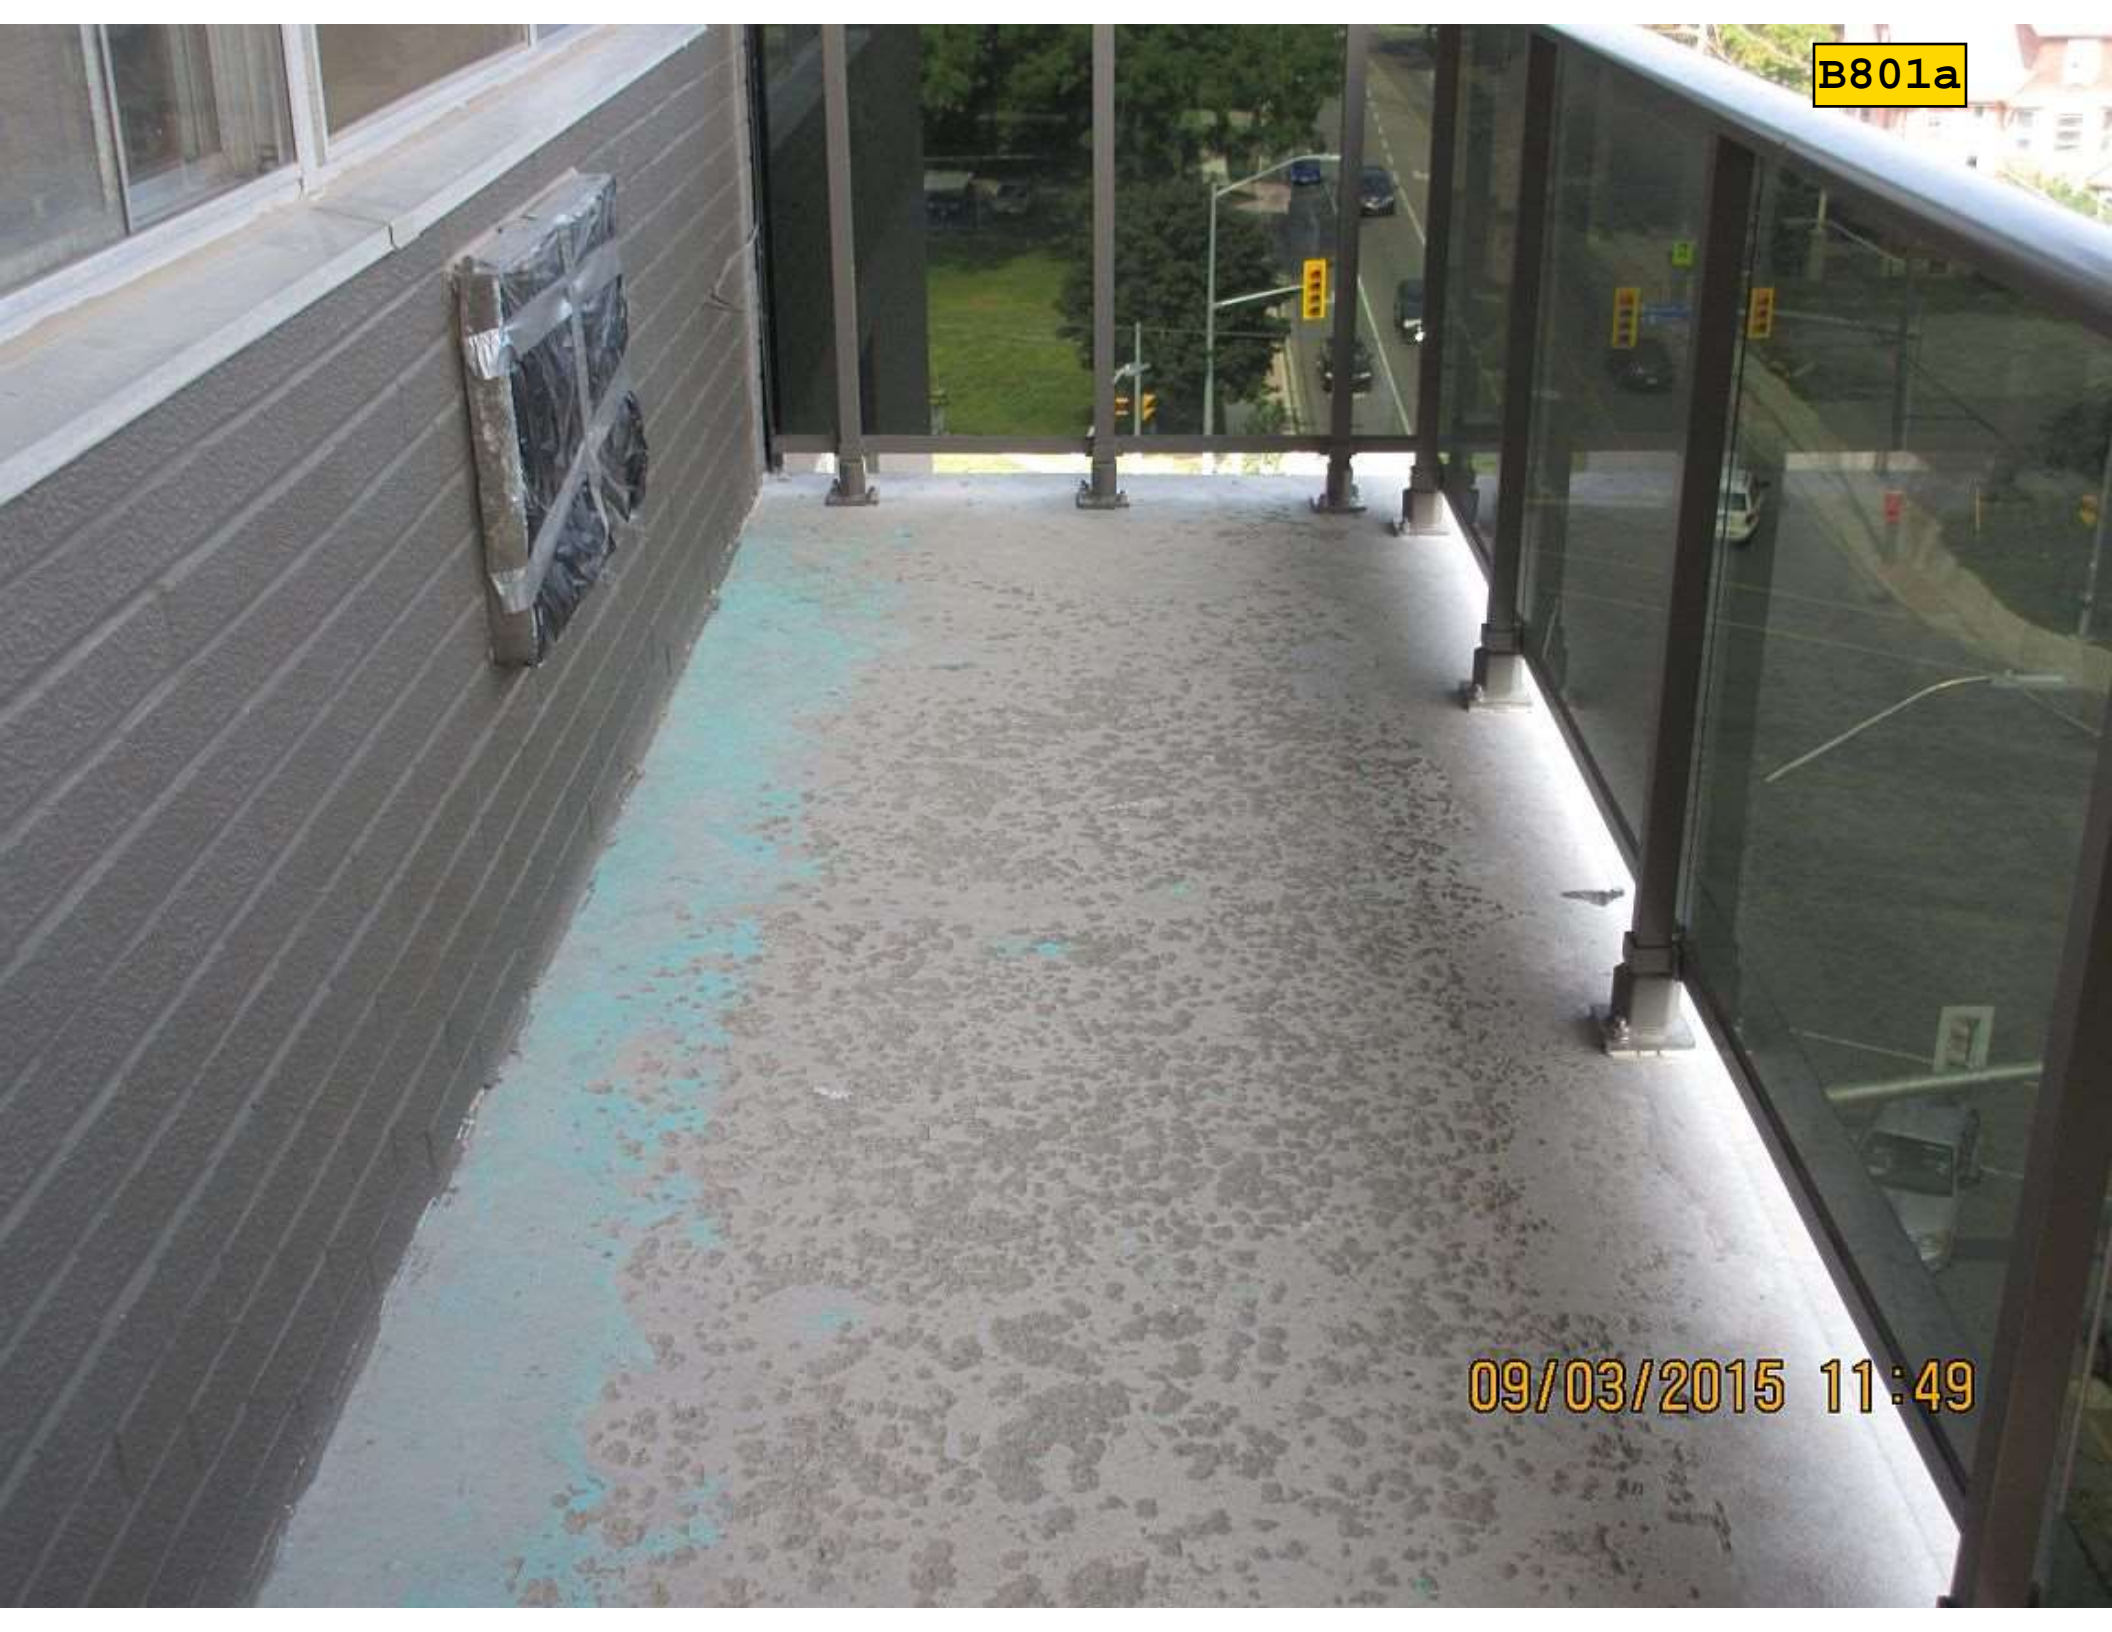
B801a

10. The only balcony I found that actually needed repair was for apartment 801. (B801a)
  - A. The finish surface of the concrete was delaminated due to an outdoor carpet.

- B. This would have been an easy repair, taking most of an afternoon to complete with simple hand tools.
  - C. It had been ignored in 3 previous balcony restoration projects.

- D. One balcony does not justify redoing all the balconies on this building.
  - E. Note these are older pictures, because unit 801 was vacant and I had no access to the balcony at the time.

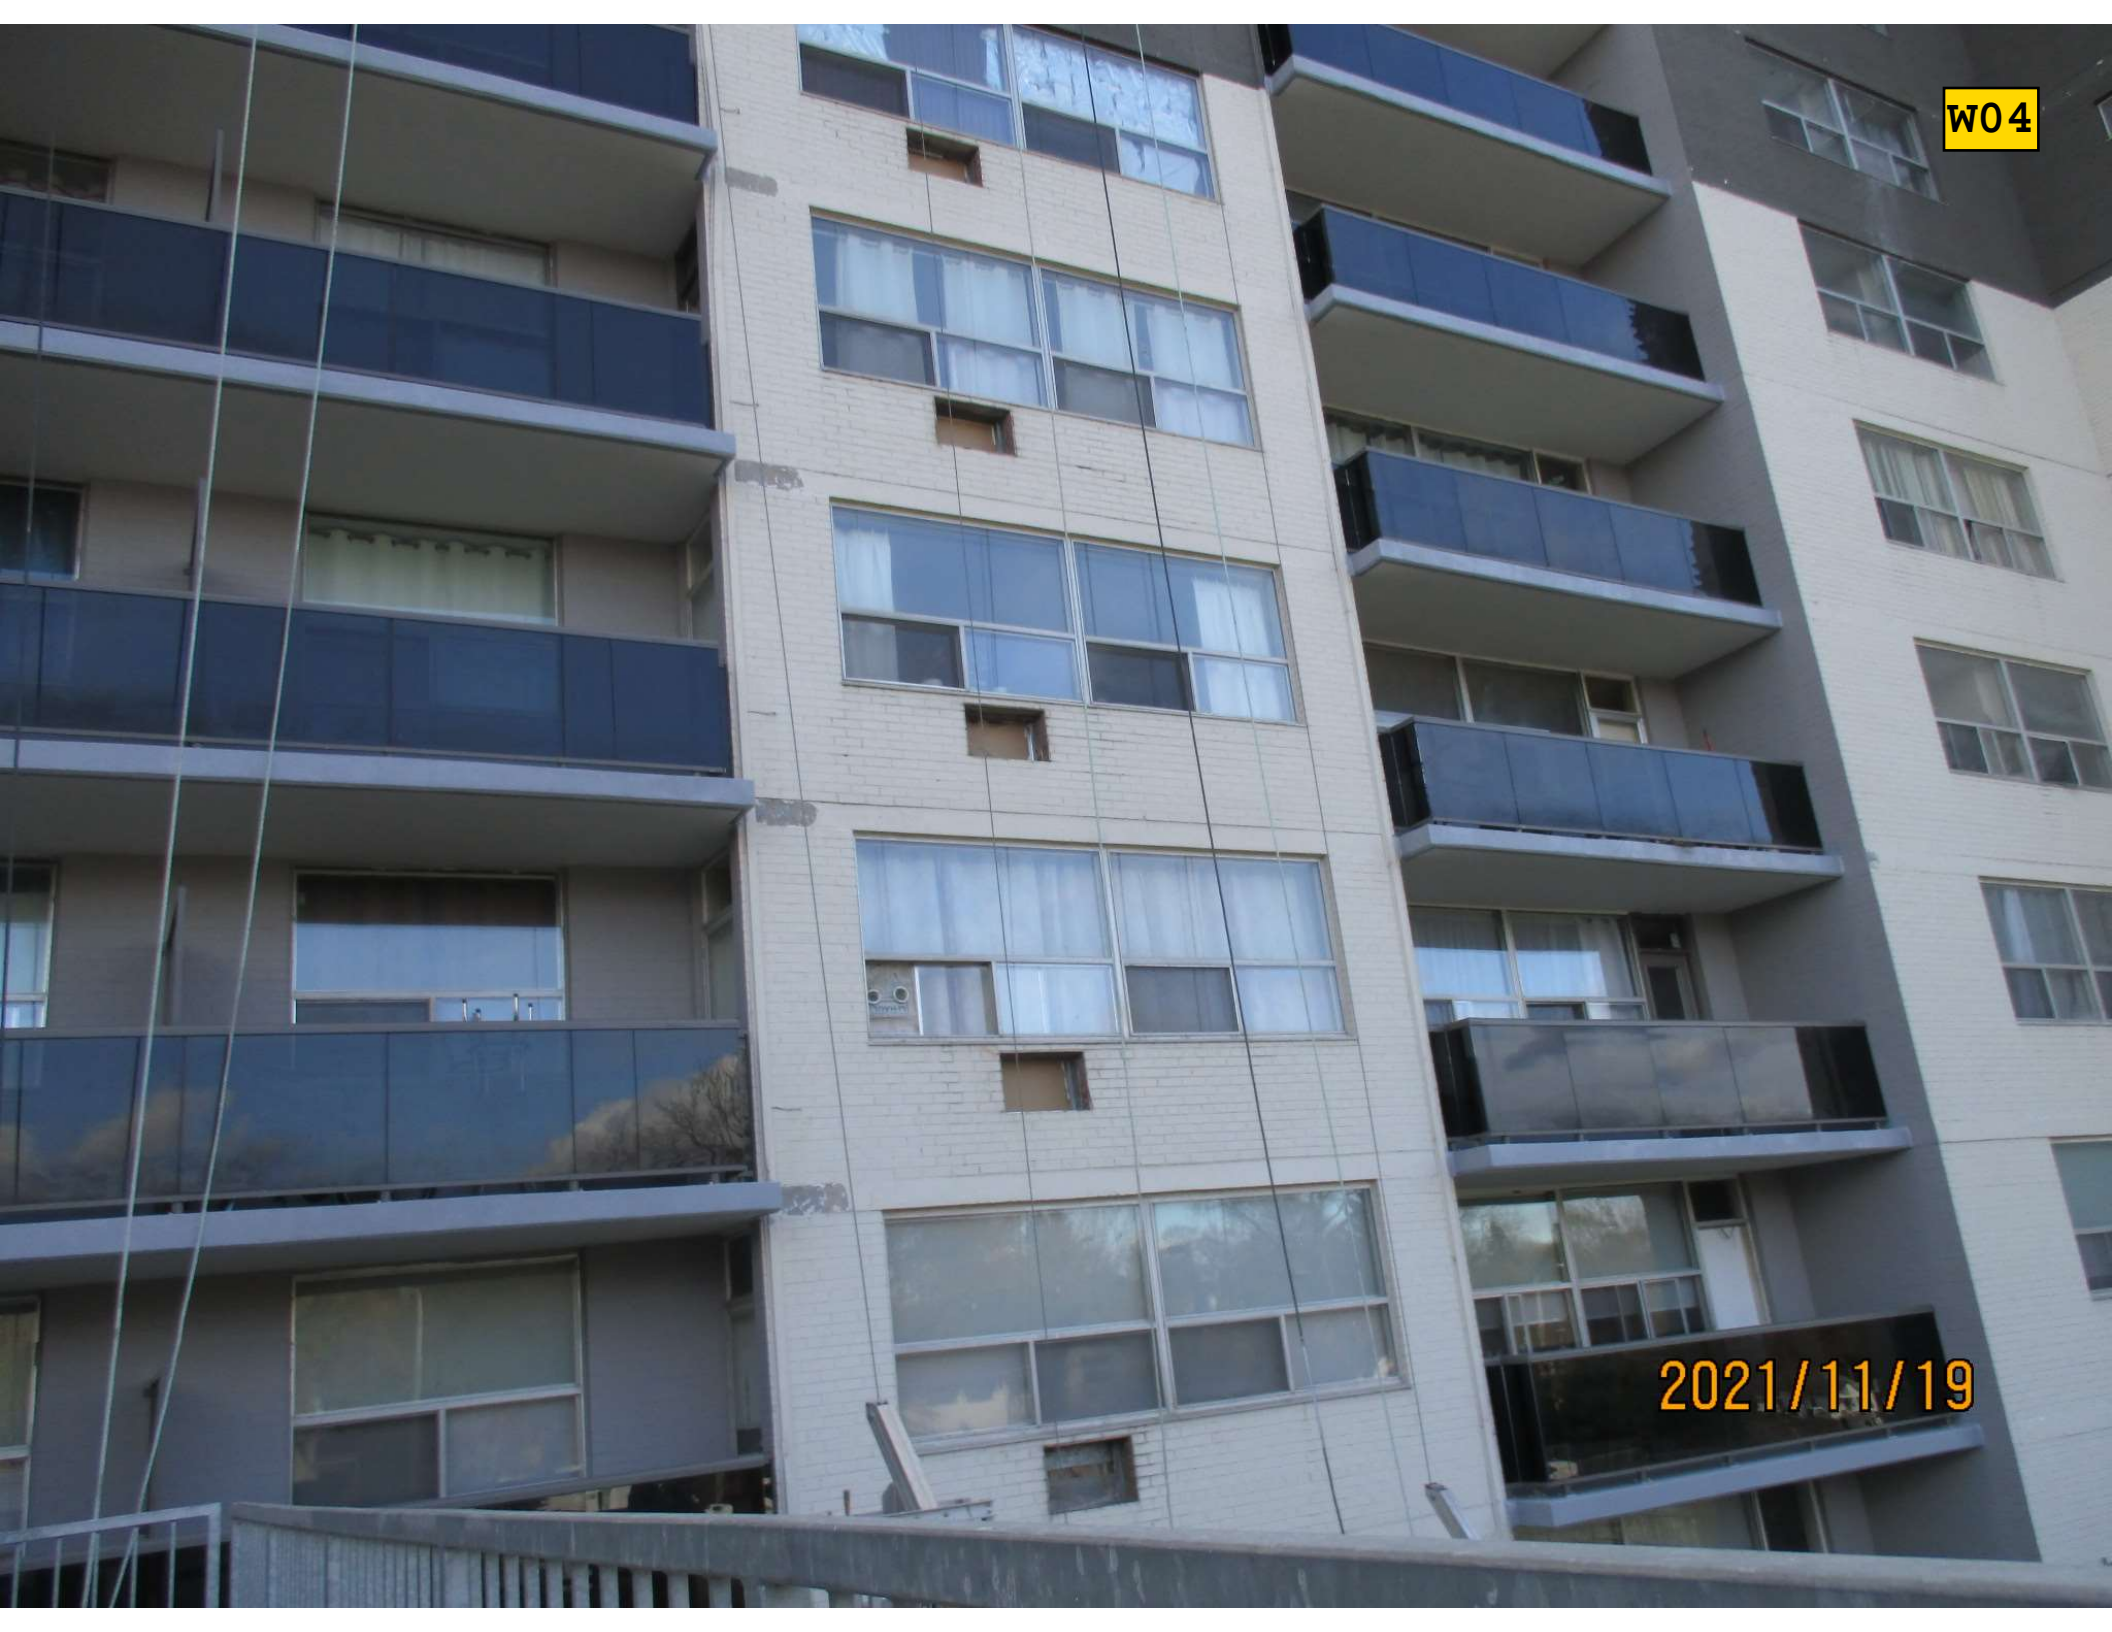
W04

8. The final section of the pictures shows the Work In Progress.
  - A. The work actually being done was largely a matter of grinding down the slab edges and ridges on the overhangs (W01, W02) then painting the slab edges and overhangs (W03, W04).

- B. This work was of little structural value and largely cosmetic in nature, akin to sanding a wall before painting.
9. The work in progress pictures (W03, W04) also show brick work being done on the sheer walls of the building.

- A. This is removing old and deteriorated air conditioner housings that were part of the original construction in the 1960s.
  - B. In discussing this with Oliver Filip, at the time, we agreed that since the interior access to these housings had been blocked by a previous landlord's unit renovations we would consider this to be a proper fix for an old problem.

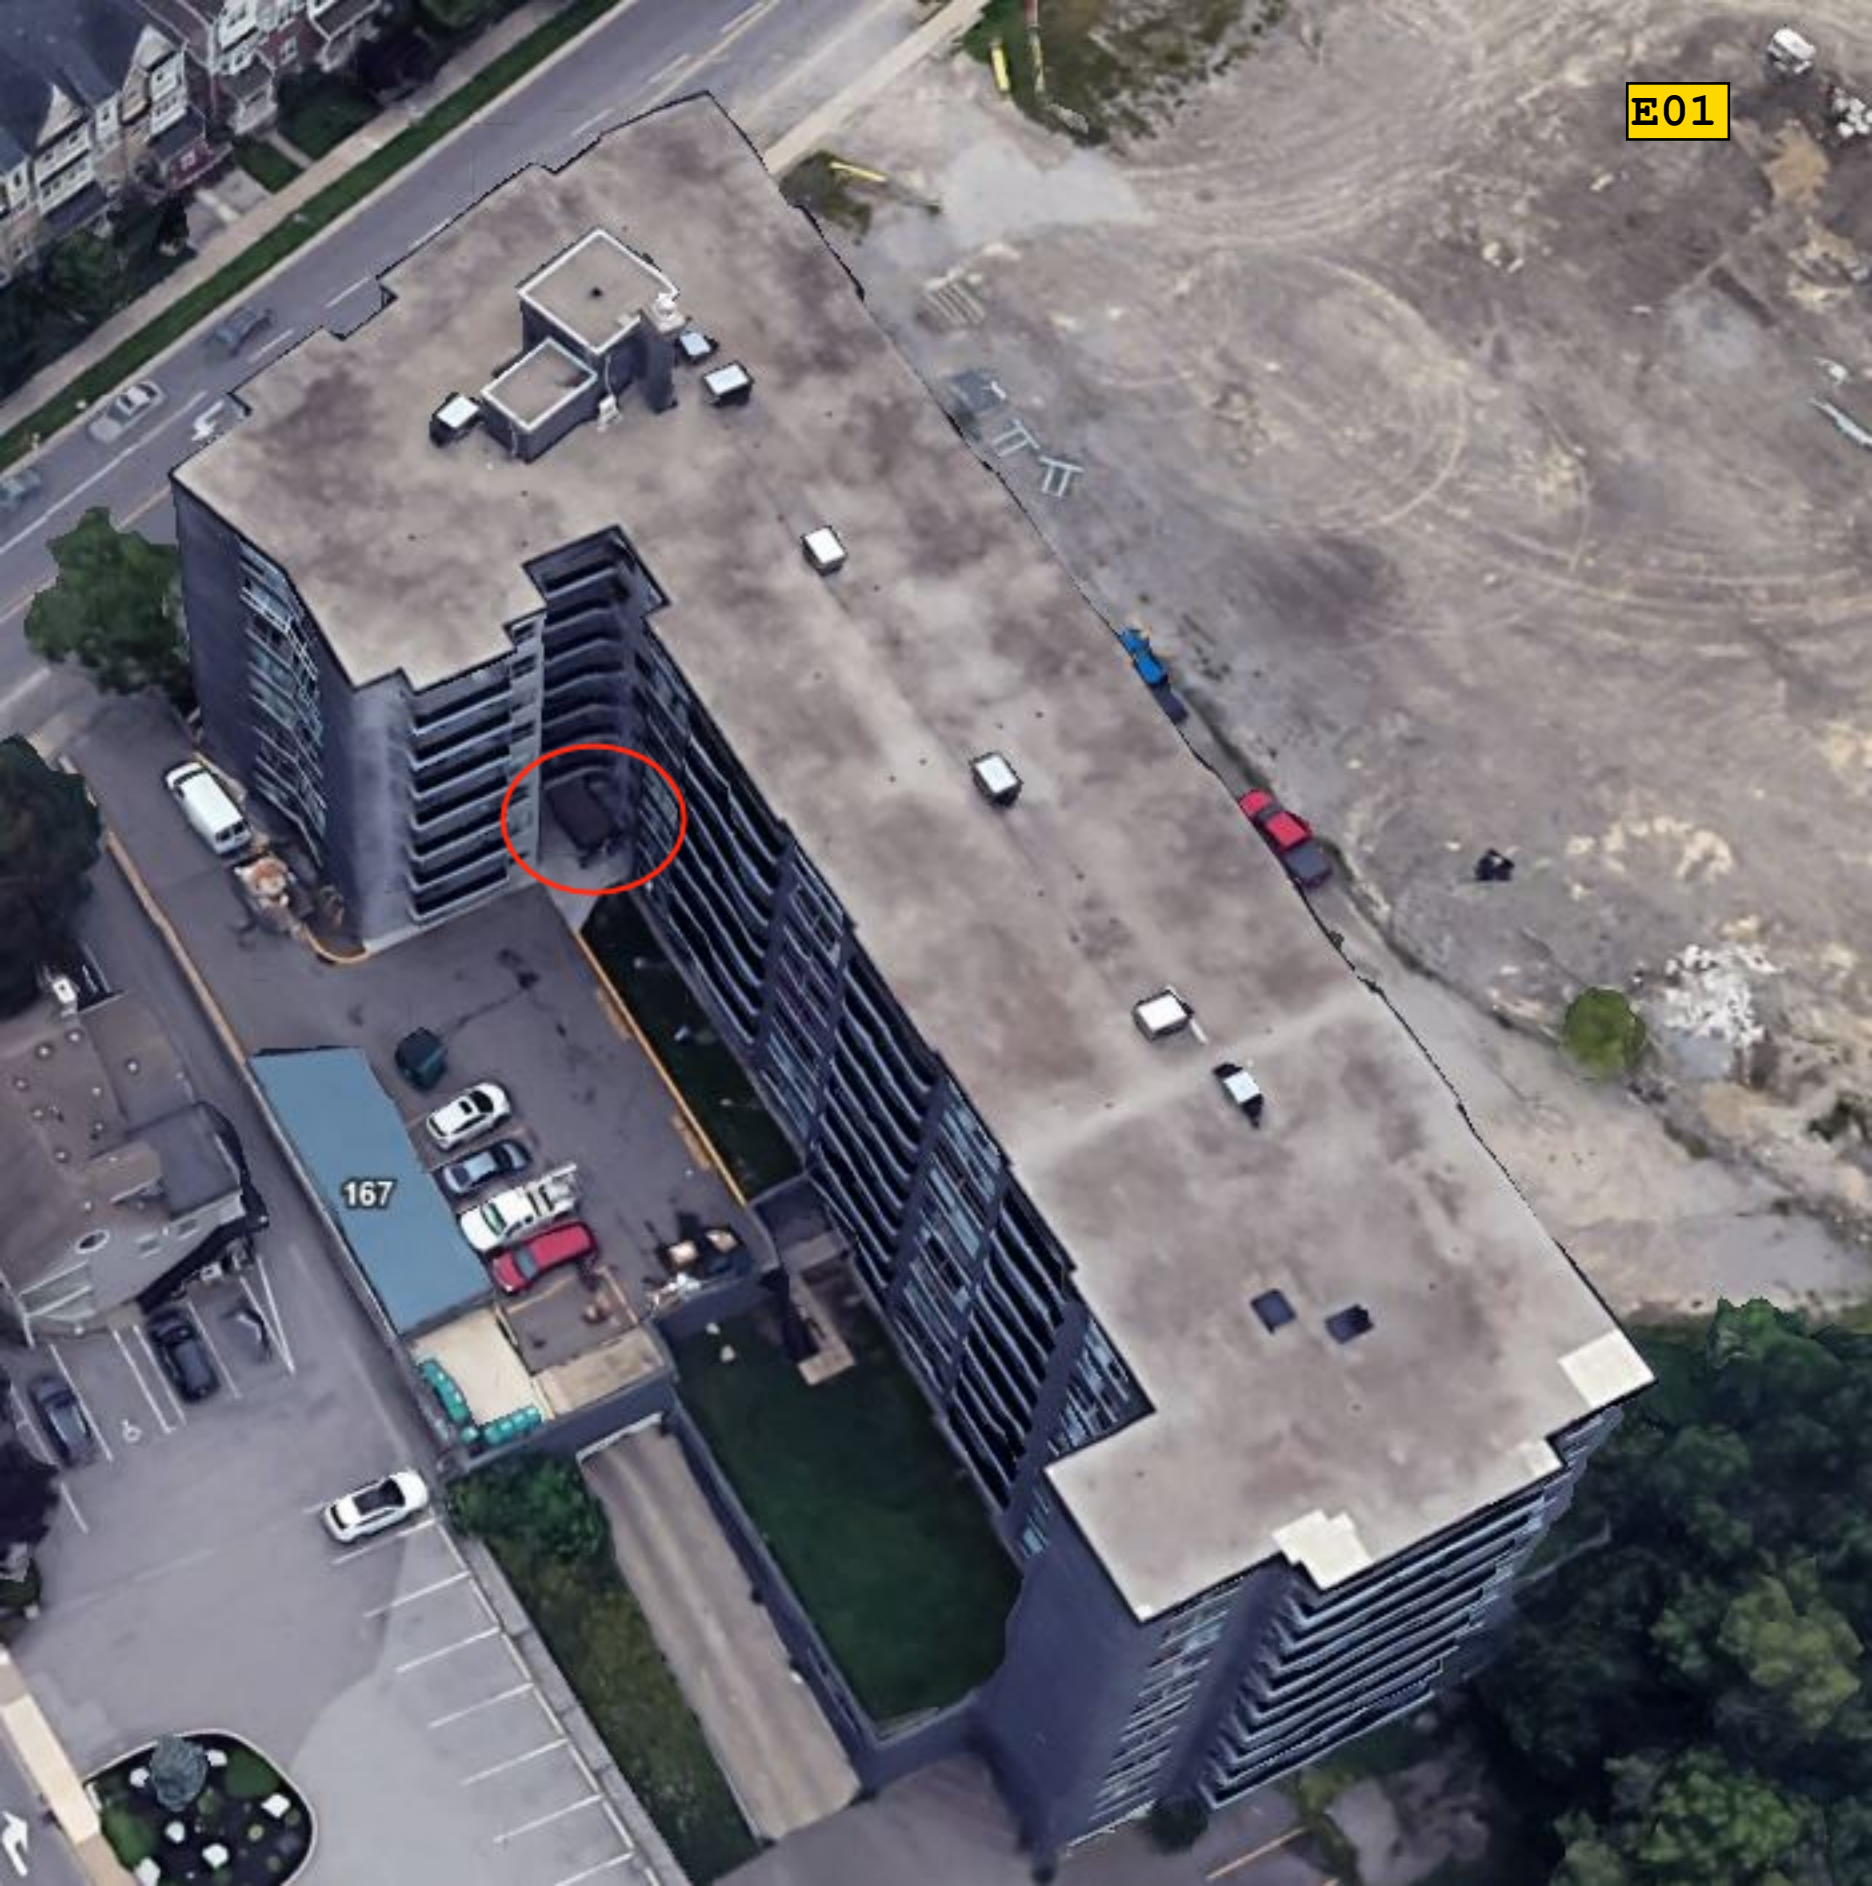
E01

Moreover; this enclosure is such a bad idea that we request that it should be removed and the rear lobby entrance should be restored to it's previous state.
